CLEVER WORKS

CCTV DRAINAGE REPORT

2022 // PREPARED BY MIHAI ANTOCE

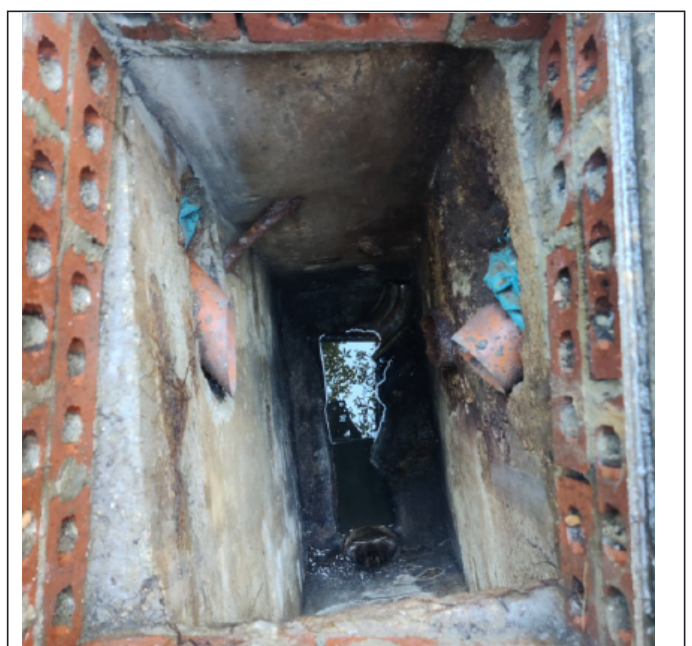
CHAMBER PHOTO

Chamber ref	MH1
Chamber invert level	1.77m
Chamber type	Manhole (demarcation)
Chamber function	Foul waste water
Chamber location	Front patio
Chamber ownership	Private (head of run)
Chamber dimensions	930mm W, 440mm L
Chamber construction	Engineering Brick
Chamber condition	Fair for age

- Previous records show this chamber was marked as UTL (unable to lift)
 - Chamber inspected as of 01/03/22

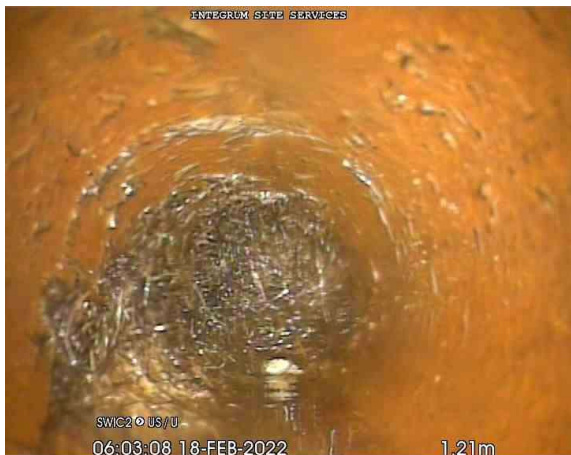
1-1-1A, 00:00:00, 0.00 m
Start node, rodding eye, reference: RE2

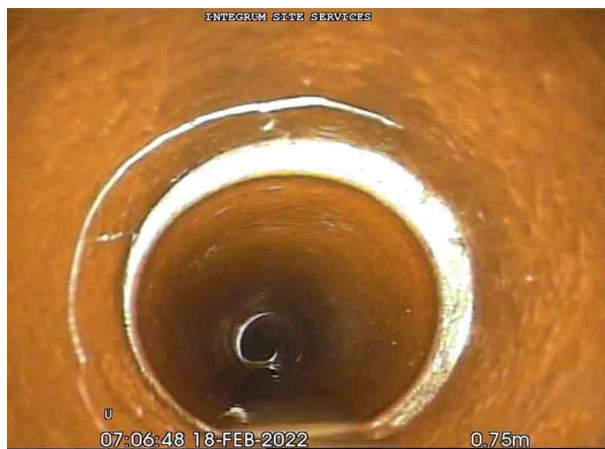
0.75	FC	Fracture, circumferential from 7 o'clock to 1 o'clock	00:00:25	1-1-3A	3 / 2
	6.47	FC	Fracture, circumferential from 9 o'clock to 5 o'clock	00:10:53	1-1-4A	3 / 2

1-1-3A, 00:00:25, 0.75 m
Fracture, circumferential from 7 o'clock to 1 o'clock

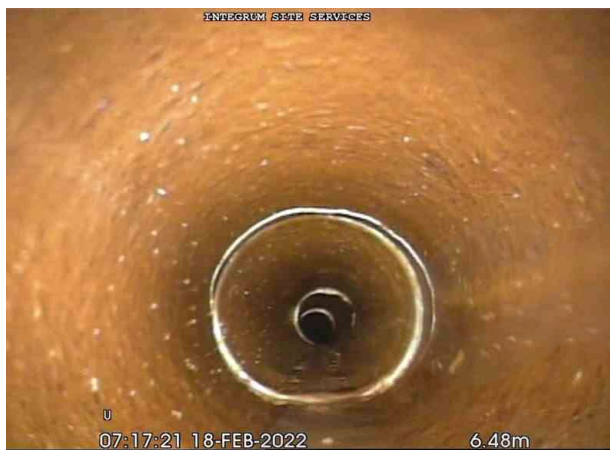
1-1-4A, 00:10:53, 6.47 m
Fracture, circumferential from 9 o'clock to 5 o'clock

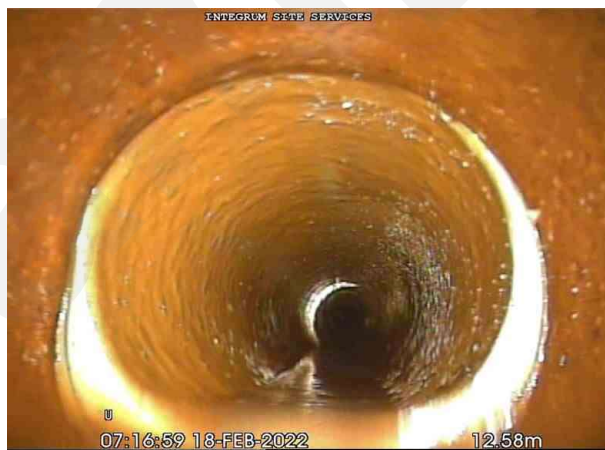
12.80	JDM	Joint displaced, medium	00:10:31	1-1-5A	1 / 3
	14.50	JDM	Joint displaced, medium	00:10:25	1-1-6A	1 / 3
	15.20	JDM	Joint displaced, medium	00:10:24	1-1-7A	1 / 3

1-1-5A, 00:10:31, 12.80 m
Joint displaced, medium

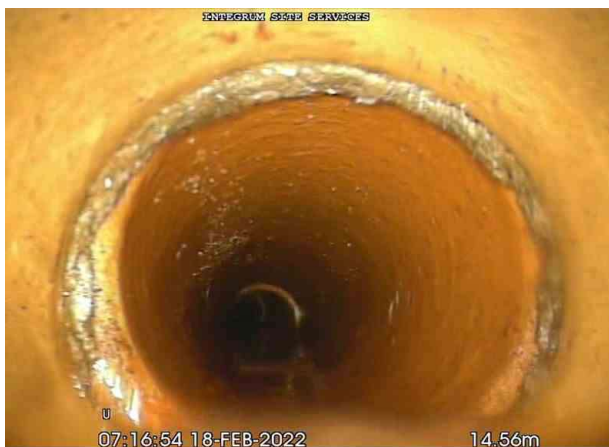
1-1-6A, 00:10:25, 14.50 m
Joint displaced, medium

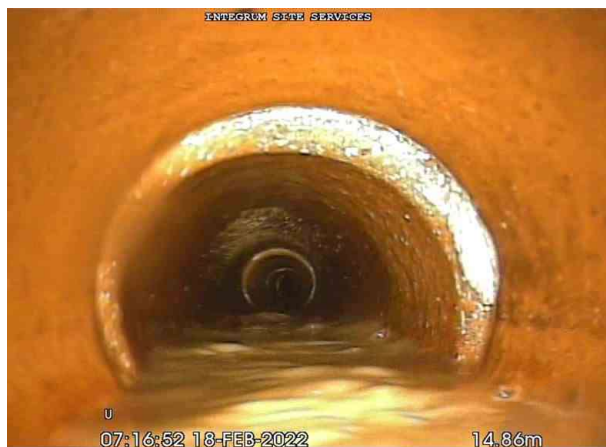
1-1-7A, 00:10:24, 15.20 m
Joint displaced, medium

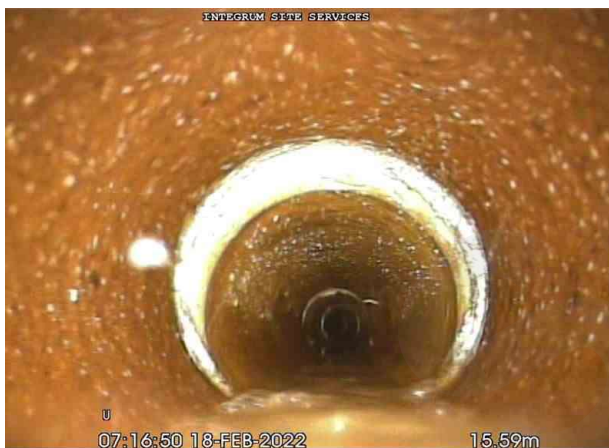
15.59	JDL	Joint displaced, large	00:10:22	1-1-8A	1 / 4
	18.53	JDL	Joint displaced, large	00:10:10	1-1-9A	1 / 4
	19.62	JDL	Joint displaced, large	00:10:08	1-1-10A	1 / 4

1-1-8A, 00:10:22, 15.59 m
Joint displaced, large

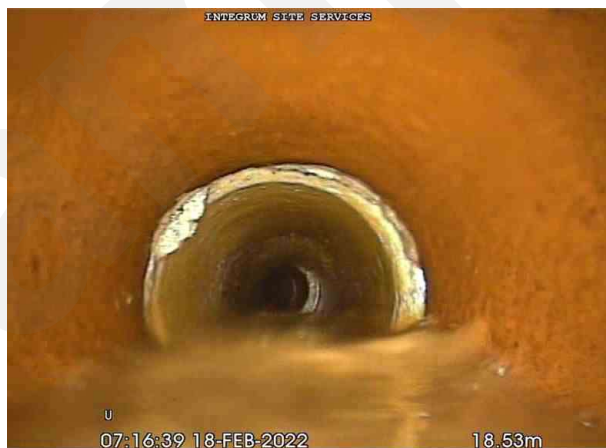
1-1-9A, 00:10:10, 18.53 m
Joint displaced, large

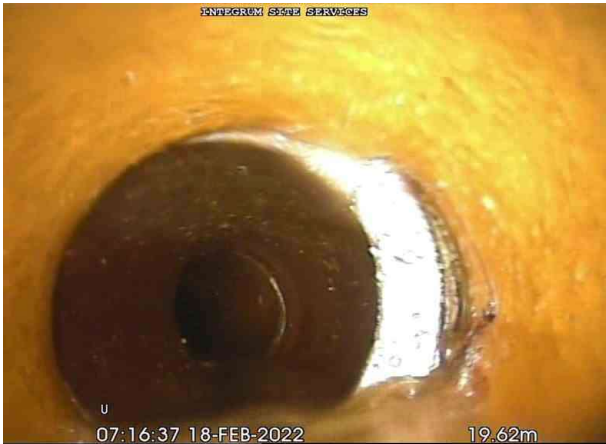
1-1-10A, 00:10:08, 19.62 m
Joint displaced, large

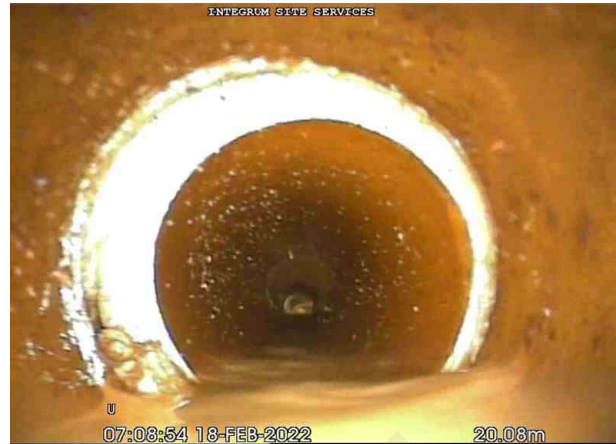
20.08	JDL	Joint displaced, large	00:02:31	1-1-11A	1 / 4
	21.00	MCZ	Pipe material changes to another material at this point: Appears to change to patch liner	00:02:46	1-1-12A

1-1-11A, 00:02:31, 20.08 m
Joint displaced, large

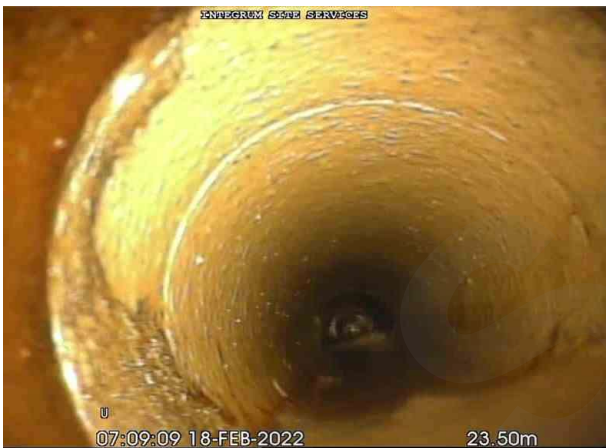
1-1-12A, 00:02:46, 21.00 m
Pipe material changes to another material at this point, Appears to change to patch liner

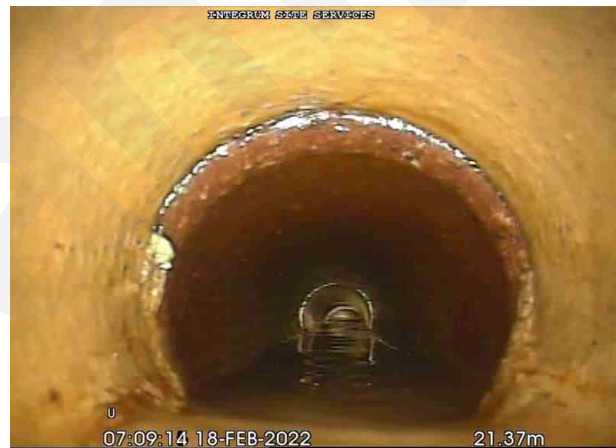
1-1-13A, 00:02:51, 21.57 m
Pipe material changes to vitrified clay at this point, 21.57

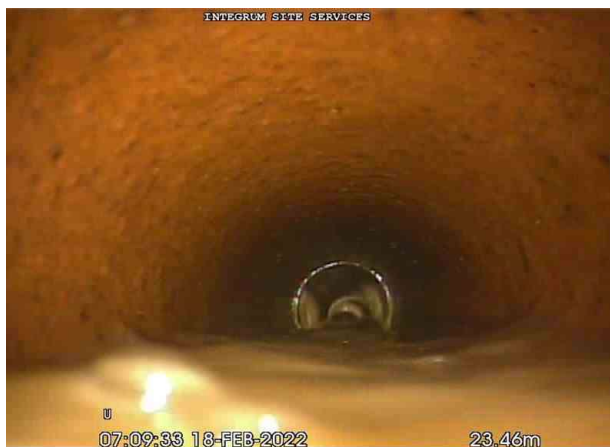
1-1-14A, 00:03:10, 23.42 m
Survey abandoned, Camera unit goes underwater and loses vision
