CLEVER WORKS

CCTV DRAINAGE REPORT

2022 // PREPARED BY MIHAI ANTOCE

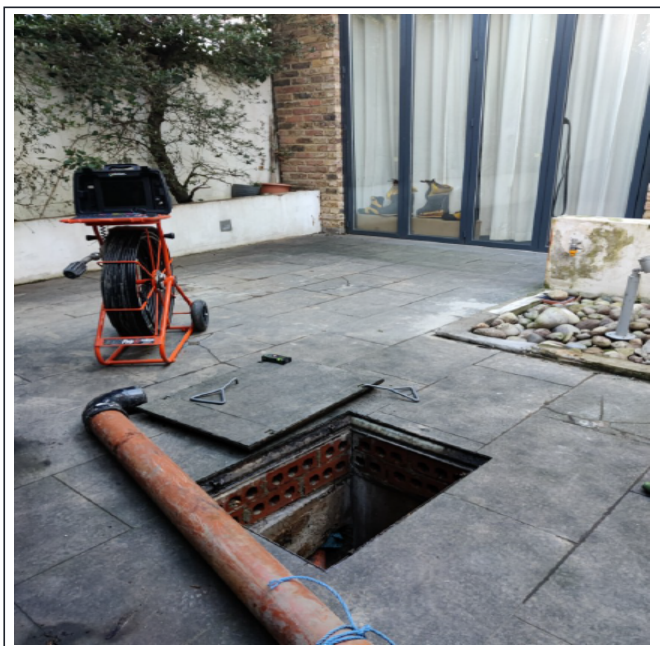
LOCATION PHOTO

Chamber ref	MH1
Chamber invert level	1.77m
Chamber type	Manhole (demarcation)
Chamber function	Foul waste water
Chamber location	Front patio
Chamber ownership	Private (head of run)
Chamber dimensions	930mm W, 440mm L
Chamber construction	Engineering Brick
Chamber condition	Fair for age

- Previous records show this chamber was marked as UTL (unable to lift)
 - Chamber inspected as of 01/03/22
